ARMY AVIATION SAFETY

- CRASH INJURY
- CRASHWORTHINESS

Final Report
U. S. ARMY
TRECUM Contract
DA 44 177 TC 624
TREC Technical Report
60 77
AvCIR 70 0 128
30 December 1960

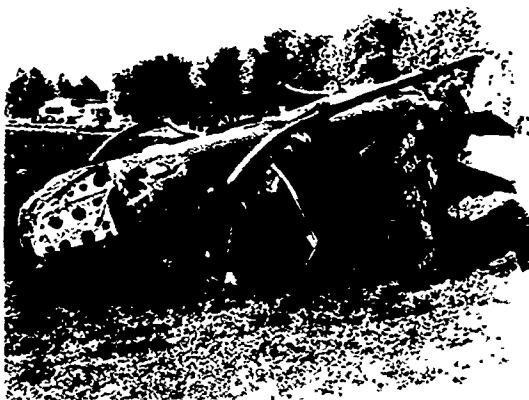
At impact the tail boom began shearing loose and tore completely free as the aircraft rebounded into the air. The aircraft struck the ground two more times finally coming to rest approximately 420 feet from the point of initial impact. During this sequence, the engine tore free from its mounts and rolled to the right of the crash path.

Cargo and cabin doors were torn free and the main transmission, mast, and rotary assembly tore free during the rolling of the aircraft near the end

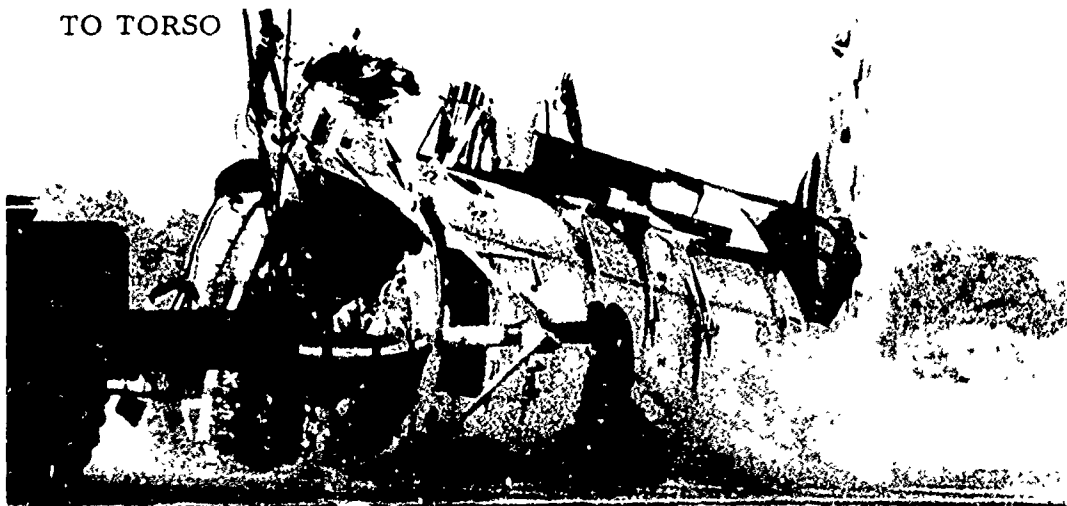
PILOT STARTS TO MOVE
UPWARD AND FORWARD
